El Hi Facility

Facility Condition Assessment Report

Ignacio, CO

167859 | July 22 , 2022

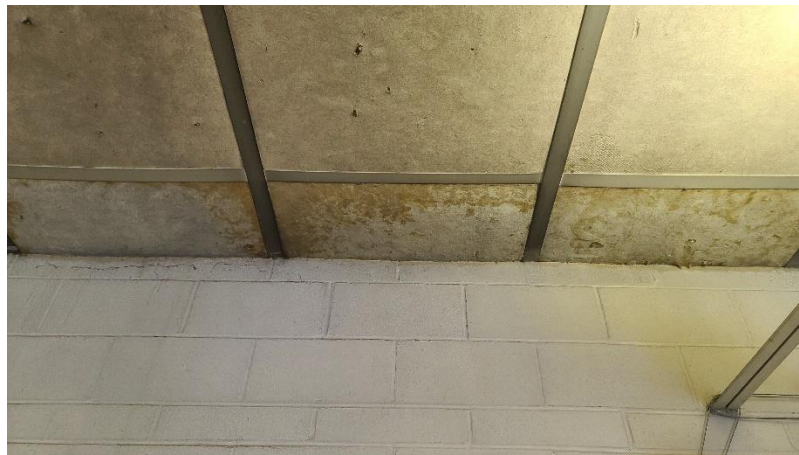
2.1.1 Finding A1: Stained Ceilings - Mold

Multiple instances of stained ceilings were observed. The likely cause is a combination of roof leaks and clogged condensate drains. It is very probable that the building has high levels of mold.

Stained Ceilings

Recommendation: Several areas of the ceiling should be replaced, and intensive mold inspection and testing is highly recommended.

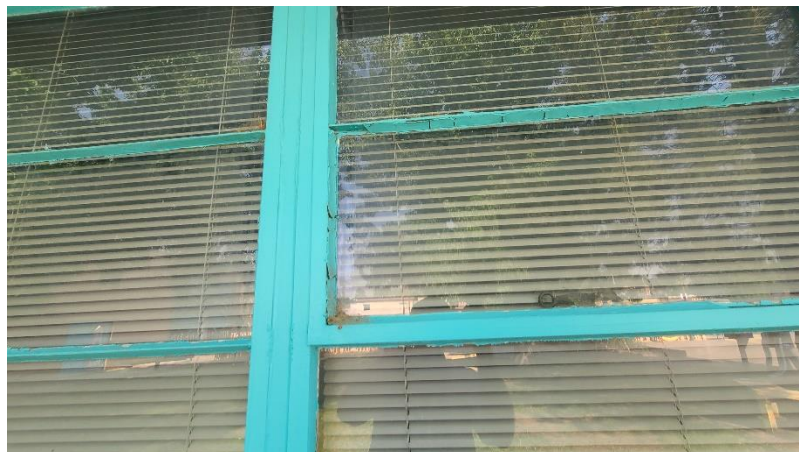
2.1.2 Finding A2: Deteriorated Glazing System

Virtually all the exterior glazing systems are single pane and have deteriorated to the end of useful life. Evidence of water infiltration was present in numerous locations. This state of deterioration significantly impacts the building energy performance and occupant comfort.

Deteriorated Glazing

Recommendation: Replace windows for most of the building.

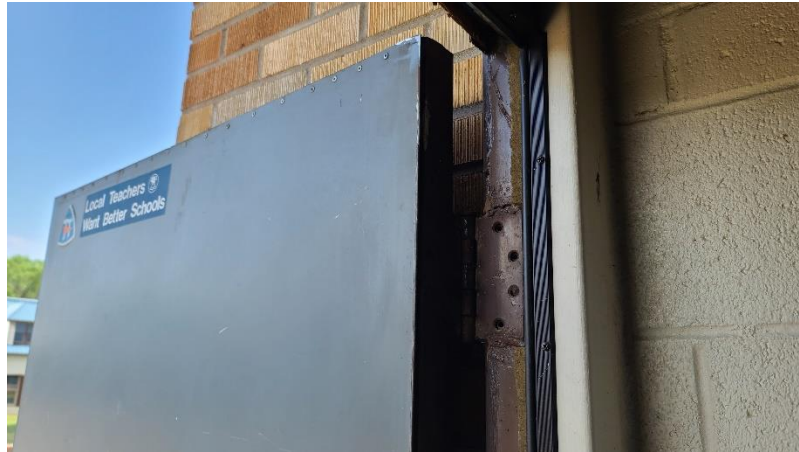
2.1.3 Finding A3: Corroded Exterior Doors

Most exterior doors are at the end of useful life. Steel doors and frames have significant corrosion and delamination. Instances of rot were observed at wood doors and frames. These are good indications that the core of the door has been compromised as well, making it ineligible for repair.

Corroded Exterior Door

Recommendation: Replace most doors in the building.

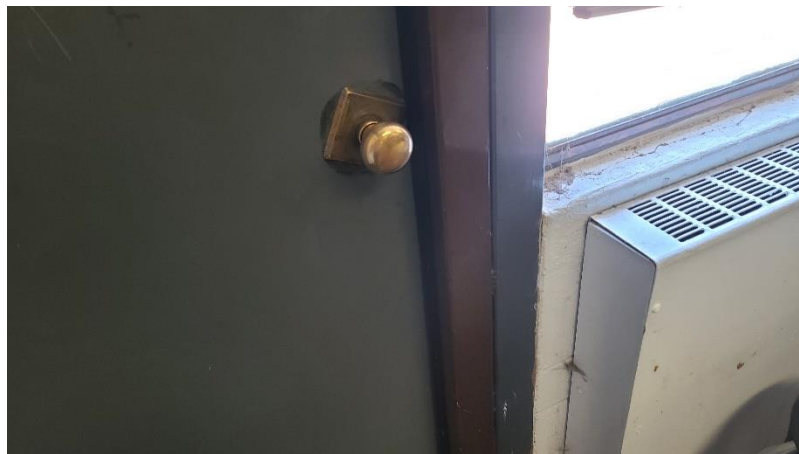
Many areas throughout the building lack ADA compliant door hardware. Several instances of loose/damaged hardware were also observed.

Non-ADA Compliant Door Hardware

Recommendation: Replace door hardware on most doors in the building.

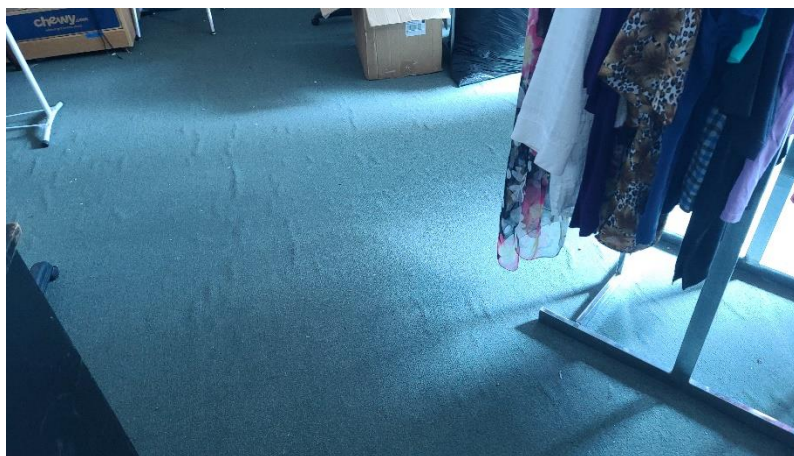
2.1.5 Finding A5: Carpeting – Worn and Stained

While some areas were observed with newer carpet installation, several areas remain worn and stained. Some carpeting has degraded to the point of being a tripping hazard.

Worn and Stained Carpet

Recommendation: Replace all carpeting that is at the end of its useful life.

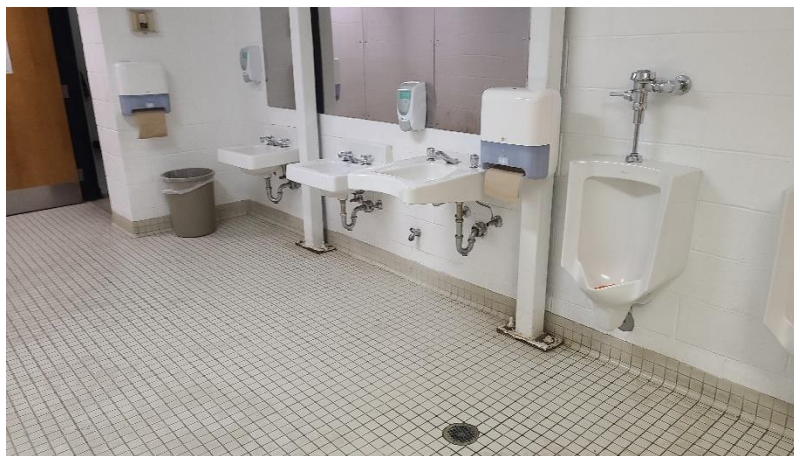
2.1.6 Finding A6: Bathroom Condition and Accessibility

While there are some bathroom conditions that adhere to ADA standards, the facility has not achieved over all ADA accessibility. Under sink piping is exposed throughout the facility, presenting a scalding risk to those without feeling in lower extremities. Several bathrooms lack toilets with grab bars and proper seat heights. ADA sinks and drinking fountains were lacking in most locations. Additionally, many of the toilet partitions are in poor condition and are not sized to accommodate use by adults.

Non-ADA Compliant Restroom

Recommendation: Update bathrooms to meet current ADA standards and intended use.

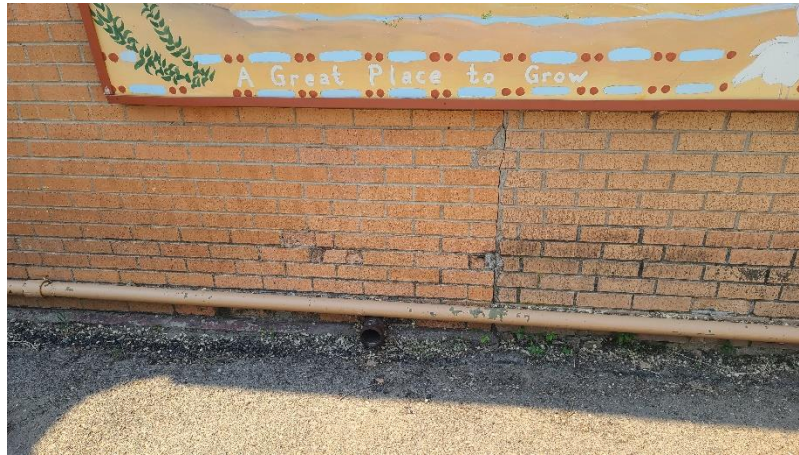
2.1.7 Finding A7: Damaged Masonry

The masonry has intermediate damage. Spalled brick and missing mortar was observed in isolated locations, but no systemic issues appear to be present.

Spalled Brick and Missing Mortar

Recommendation: spot repair masonry and mortar as needed.

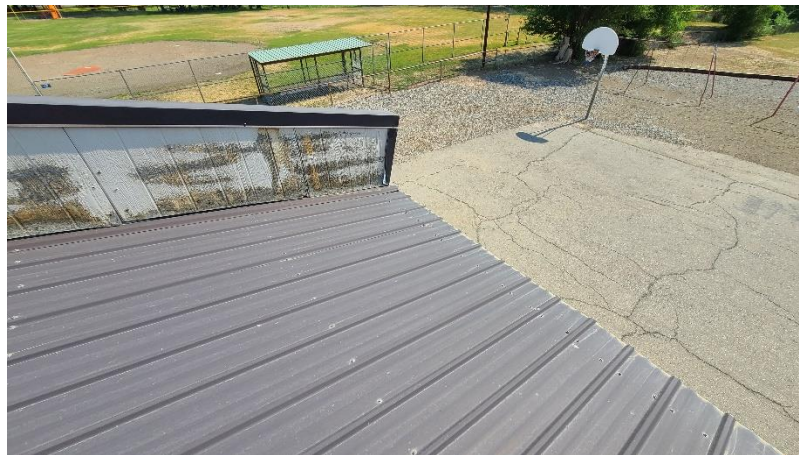
While the metal roof panels look to be in good condition in many areas, there are sections of the roof that have significant weathering and are at end of their useful lifespan. Near eaves of many of the panels, both good and poor condition, the fasteners are backing out, which is an indication that structure and substrate is failing and the roof is lifting during stronger wind events.

Lifted Fasteners on Roof

Recommendation: Repair or replace the older roof panels and repair structure/substrate as needed.

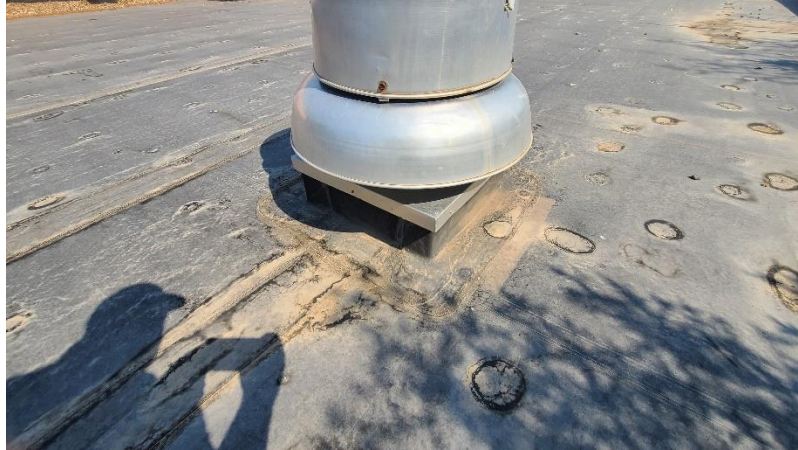
2.1.9 Finding A9: Membrane Roofing – Deterioration

While no evidence of recent leaking was present, there are signs that the roofing is nearing end of design life. Facility Staff indicated patching has been needed in recent years. Also alligating is present in many locations, especially at roof seams. Given the regional climate, black membrane roofing does not typically have a long lifespan.

Deteriorated Roof System

Recommendation: Replace existing membrane with white membrane roof to ensure a permanent solution.

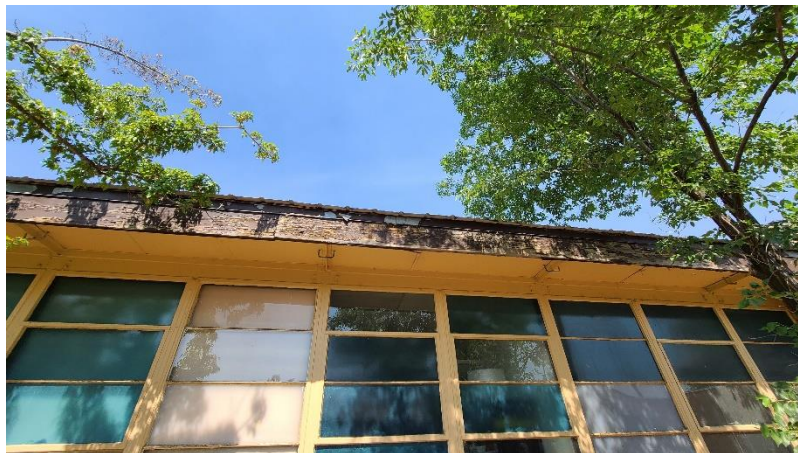
2.1.10 Finding A10: Wood Eaves and Soffits – Deterioration

Where painted wood eaves are present, significant peeling paint and rot is generally visible.

Peeling Paint and Rot on Wood Eaves

Recommendation: Replace most of the wood soffits with new wood backer and provide prefinished metal fascia.

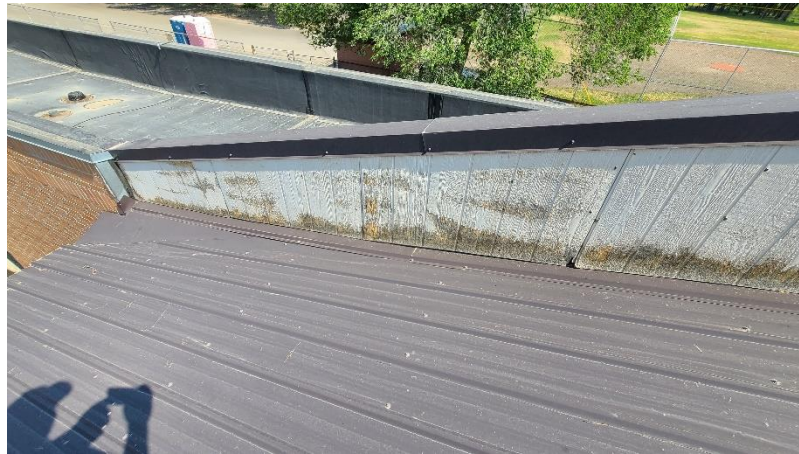
Several areas of the wood siding at end walls of the roof were observed with generally failing coating and evidence of mildew and water damage.

Mildew and Water Damage at Parapet Wood Siding

Recommendation: Replace parapet wood siding with a more durable material, such as metal siding.

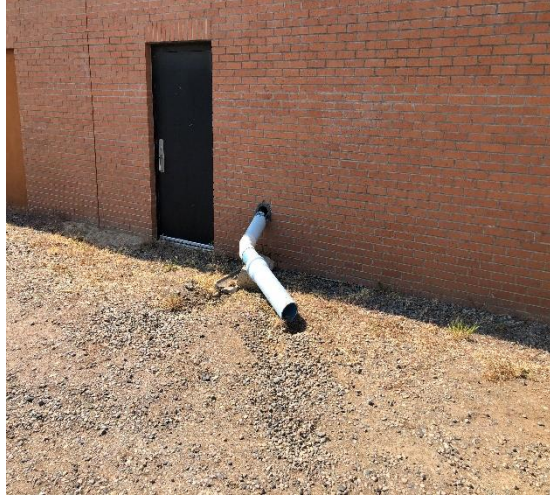
2.2.1 Finding C1: Inadequate Drainage on North Side of Building

Description: There are two roof drain downspout outlets (lamb tongues) on the north side of the building with inadequate drainage. These outlets are located 2-ft above the exterior grade, and PVC pipes have been added to each outlet to get the runoff further away from the building. The PVC pipes do not appear securely attached and represent a tripping hazard on the site. Plus the pipes do not extend further than 5-ft, and the gravel parking area does not appear to have sufficient positive drainage to convey runoff away from the building.

Roof spout drain on north side

Recommendation: A landscape drain system should be installed to collect roof downspouts and drain site runoff away from the foundation to the east side of the building where grade change will allow a storm drain to daylight.

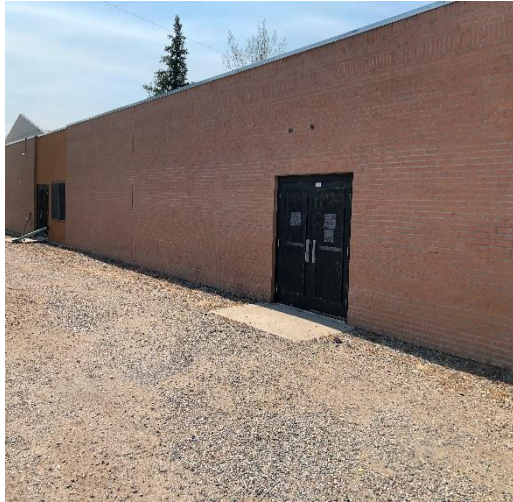
2.2.2 Finding C2: Inadequate ADA access on north side of building

Description: There are three doors into the building located on the north side, two of these have concrete landings outside the door. The doors open to the gravel parking area without a paved walkway connecting them to the front of the building or street.

Entry on the north side of building with no walkway

Recommendation: A paved walkway linking these doors with the main parking area is required if these doors are to be used for ingress/egress.

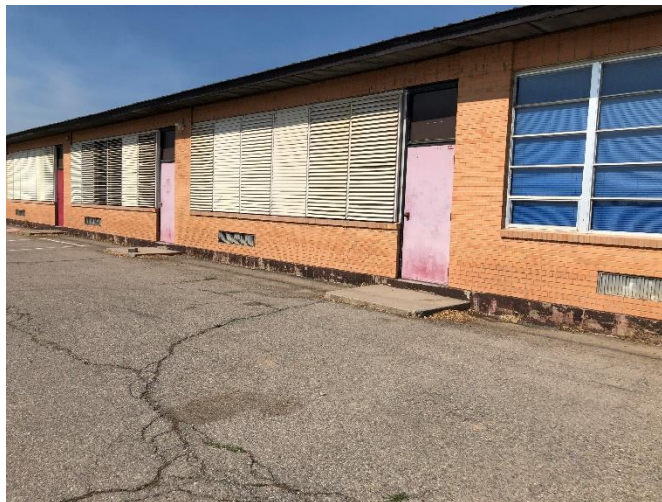
2.2.3 Finding C3: Inadequate ADA access on east side of building

Description: There are multiple doors located on the east side of the building. Each door has a drop at the threshold of a few inches and then a concrete landing. The concrete landings sit an inch or two above the exterior play area pavement. The grade drop at the thresholds, grade drop at the concrete landings, and the cross slope of the existing paved area all exceed ADA requirements.

Entry on east side of building with concrete stoops.

Recommendation: To provide adequate ADA access to these doors, a new paved walkway would need to be constructed from the main parking area to the east side of the building. This would require grading and drainage improvements as well.

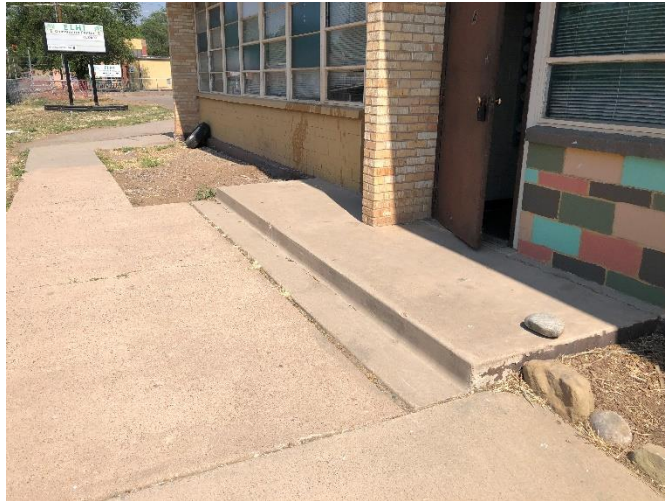
2.2.4 Finding C4: Inadequate ADA access on west side of building

Description: A paved sidewalk on the west side of the building accesses multiple doors, an interior courtyard and provides access to the play area on the south side. This sidewalk exceeds ADA standards for cross slope and running slope in multiple locations. Additionally, access to the interior courtyard and one door is provided by a concrete risers without a ramp option. The existing sidewalk also has a blocked sidewalk chase drain that needs to be repaired or replaced.

Entry on the south side of building with concrete step.

Recommendation: To provide adequate ADA access, the existing paved walk needs to be removed and replaced with a new paved walkway. Additionally, ramps meeting ADA requirements need to be added to provide ADA access to ingress/egress locations on this side of the building. This will require grading and drainage improvements as well.

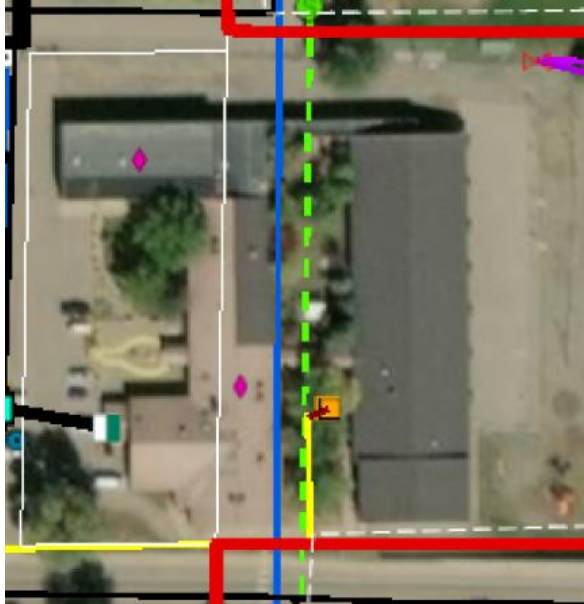
Description: The Town of Ignacio ARCGIS database shows a water main and sewer main located within the building footprint on a north-south axis primarily through the courtyards. This needs to be confirmed with utility locate methods. Also, an overhead electric line is located on the same alignment and spans over portions of the building.

Image from ARCGIS showing sewer/water main locations

Recommendation: If confirmed, the water and sewer mains will impact future development of the site. The mains need to be relocated before new building construction can be performed on the site. The presence of the mains also puts the existing building at greater risk from damage from leaks or required maintenance. The overhead electric line should also be relocated around the site prior to any redevelopment.

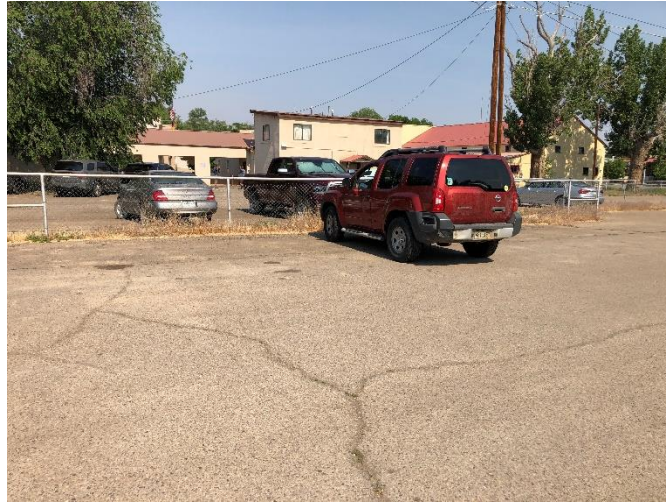
2.2.6 **Finding C7: Existing paved parking area shows signs of failure**

Description: The existing paved parking area on the west side of the building shows both longitudinal and lateral cracking as well as areas of alligator cracking. Additionally, the paved surface is worn and unraveling to gravel. The majority of the parking area is unstriped which leads to inefficient parking. ADA parking spaces are striped but do not meet current dimension and signage requirements.

Paved parking area no west side with cracking.

Recommendation: Short term measures such as crack sealing may prolong the useful life of the surface. The pavement will need to be removed and replaced in the near future. The new paved area should be striped to delineate parking spaces and drive aisles.

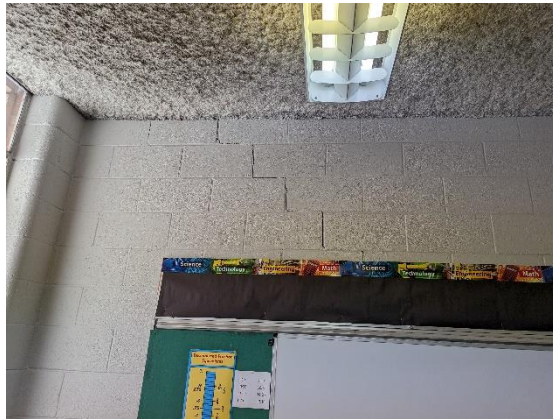
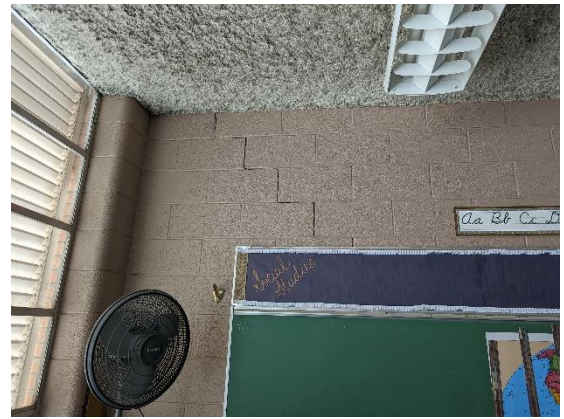
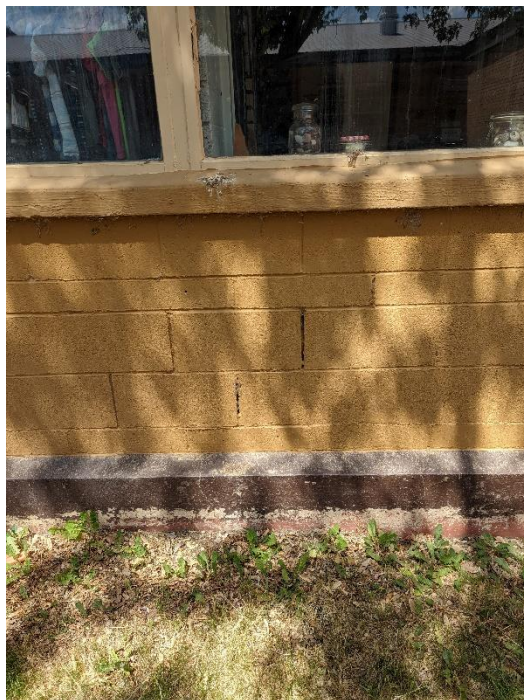
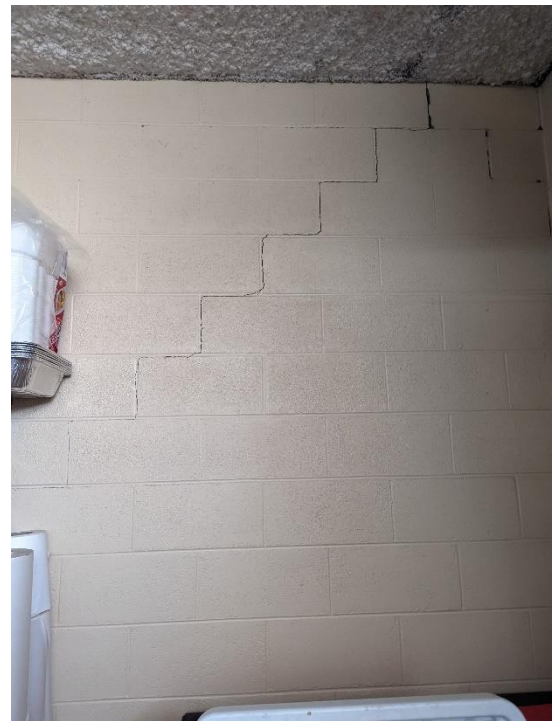
2.3.1 Finding S1: Masonry Cracking

There is extensive cracking in the masonry walls throughout the building. The cracking is found in both load bearing and non load bearing walls. The side of the building currently being used by the charter school exhibits cracking in nearly all of the partition walls between classrooms. The location and consistency of these cracks is consistent with settlement of the exterior wall. It was not possible to observe the foundation below grade, so a detailed survey would need to be performed to determine the magnitude of any settlement.

Masonry Cracking

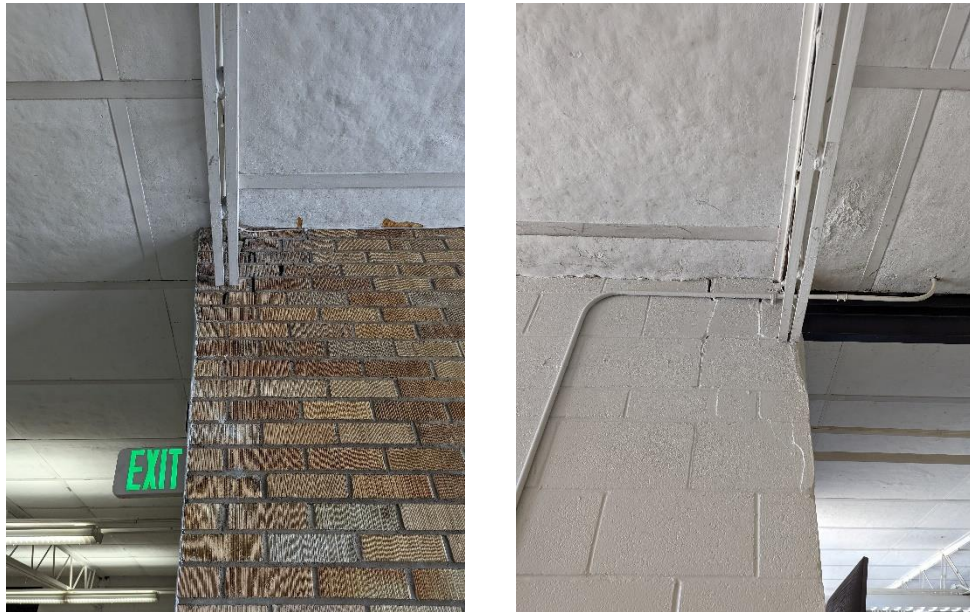
The wall support locations for the steel joist at the cafeteria exit door are compromised. The masonry has cracked and shifted at both ends of the joist.

Compromised Joist Bearing

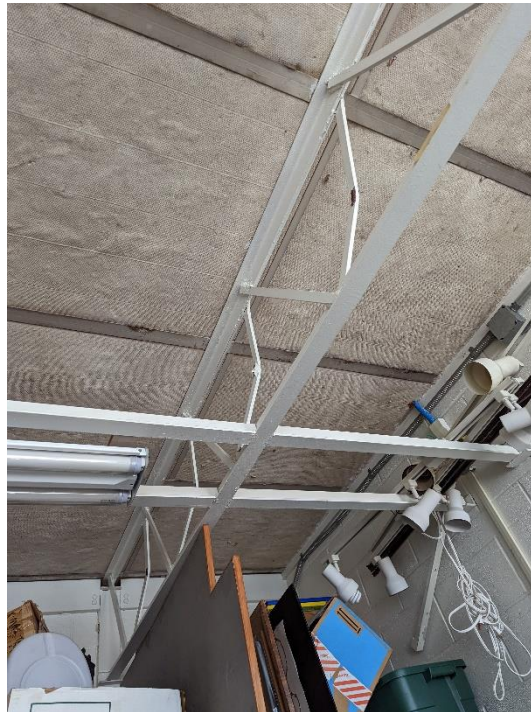
The original steel roof joists in the kiln room (room 20) have buckled. The joists appear to be fabricated out of bar stock, and these bar stock web members have failed in the weak direction. While these steel members no longer make up the roof framing, the new wood roof is supported in the attic with a wood pony wall that bears on the existing joists. This pony wall concentrates the roof loads that were previously distributed along the joist to a single point. While the total load on the joist is similar to the original design, open web steel joists are not designed to carry large point loads, which has likely led to the buckling of the joist.

Buckled Steel Joist

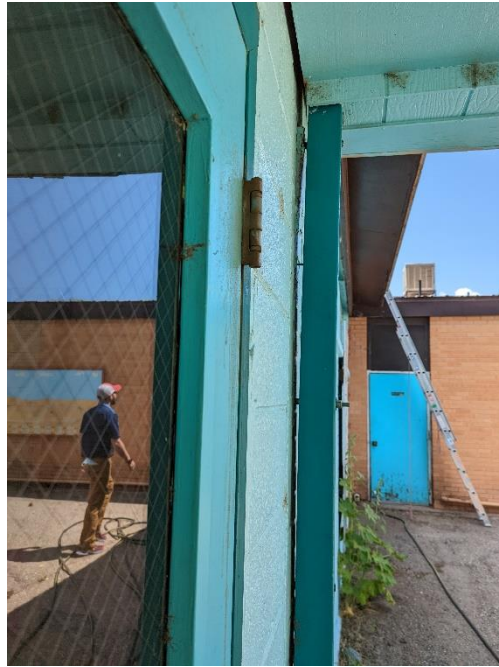
One of the columns supporting the entry canopy has deflected and separated from the building

Entry Canopy Column

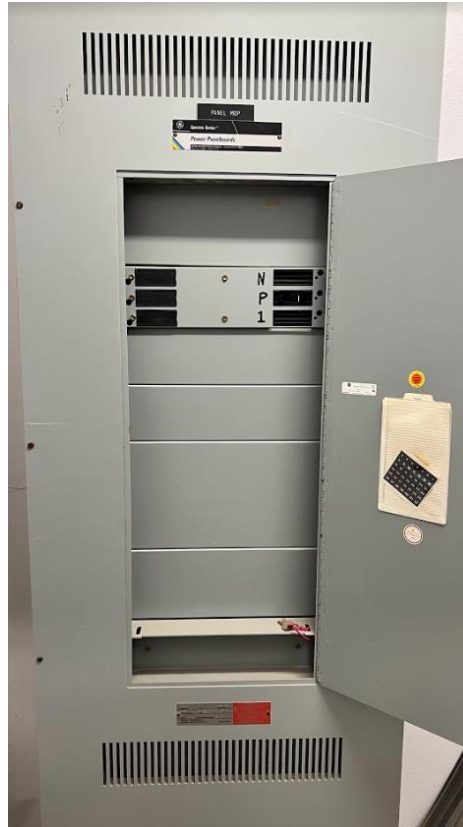
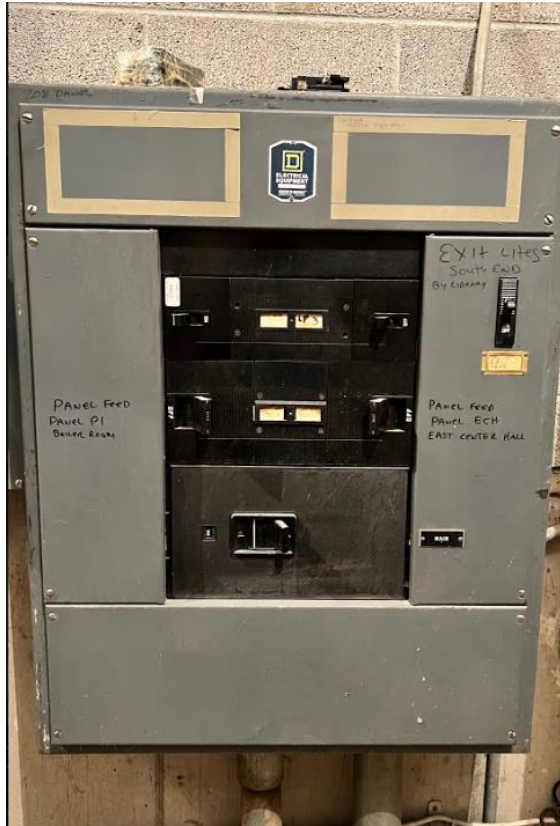
The National Electric Code requires facilities with more than one service entrance to have signage informing first responders and/or any maintenance staff of the fact that there are multiple electrical service entrances as well as where the service disconnects are located. The El Hi Community Center does not have any such signage.

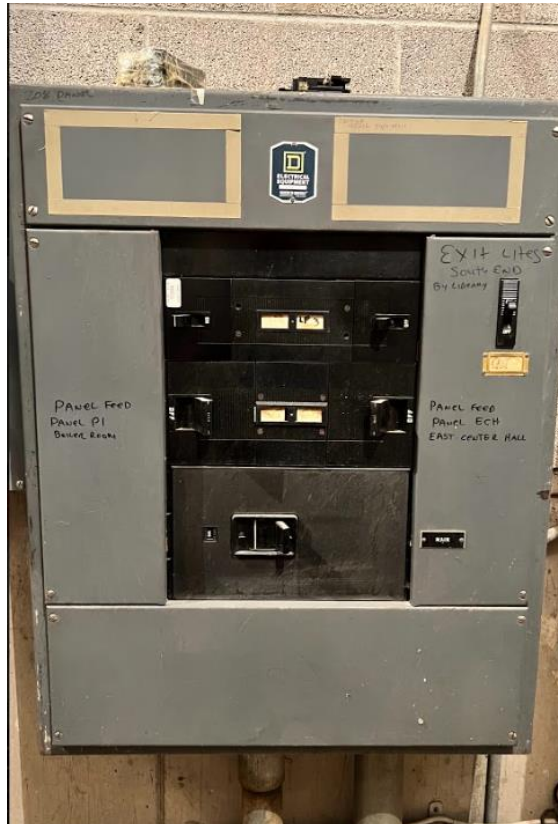
Figure 16: Existing 1-Phase Electrical Service MDP

Description: The 120/240-Volt 1-Phase 3-Wire electrical distribution equipment is beyond its useful life and no longer meets the National Electric Code. In addition, many of the receptacles, light switches, and other electrical devices throughout the building are damaged or beyond their useful life.

Recommendation: Eliminate the 1-Phase electrical distribution system completely. Replace the existing 3-Phase service equipment and service conductors. Upgrade and expand a new 3-phase electrical service to the entire building. This shall include a new MDP, new electrical panels, new feeder and branch circuit conductors, as well as replacement of any damaged or beyond useful life electrical devices.

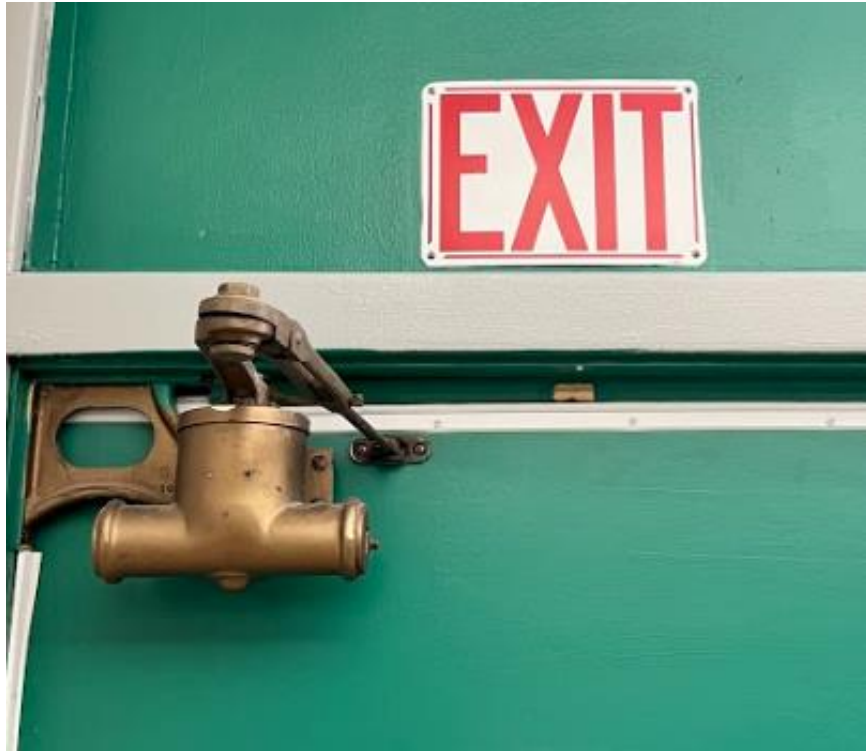
Figure 17: Current Basement Layout

Description: The ELHI Community Center contains many instances of placard style exit signs. These signs are not illuminated under any power status (normal or emergency) and are just affixed to the wall above the doorways. This is a life safety code violation.

Recommendation: Contract a life safety standards specialist to conduct a space-by-space investigation of interior and exterior of the building to ensure the safety of any occupants and/or first responders.

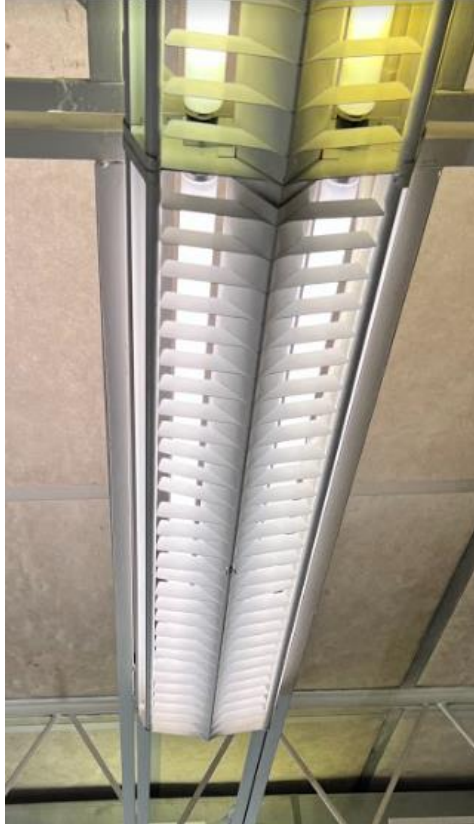
Figure 18: Example Fluorescent Fixture

Description: The lighting throughout the El Hi Community Center consists of inefficient fluorescent fixtures. The upgrade to LED fixtures and installation of automatic controls would increase energy efficiency, reduce utility electricity costs, as well as reducing maintenance costs associated with fluorescent fixtures.

Recommendation: Replace fluorescent fixtures throughout the building with LED type fixtures and install automatic controls in appropriate spaces.

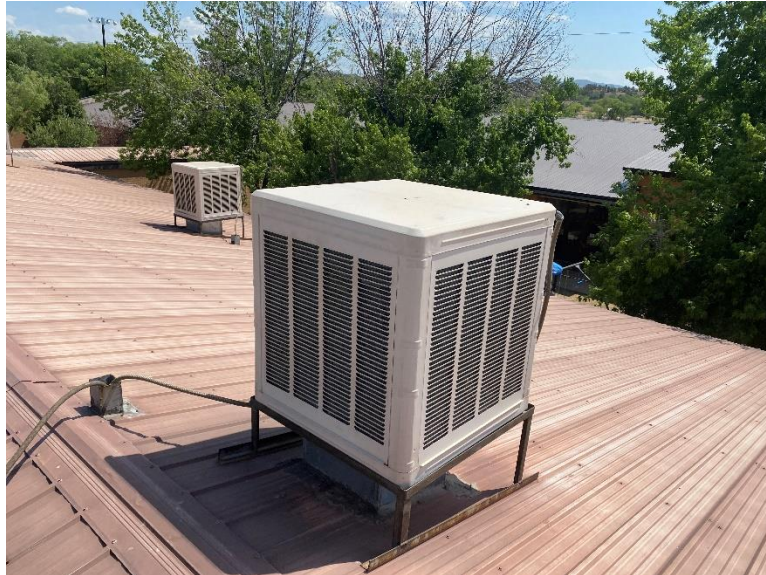
Description: The existing swamp coolers are original to the construction of the facility and are beyond their design life.

Swamp Cooler

Recommendation: Remove existing HVAC systems throughout the building. Engage a mechanical engineer to perform ventilation calculations and determine the building's heating and cooling requirements. Replace existing HVAC systems with new central, forced air HVAC system with ducted supply and returns to all rooms.

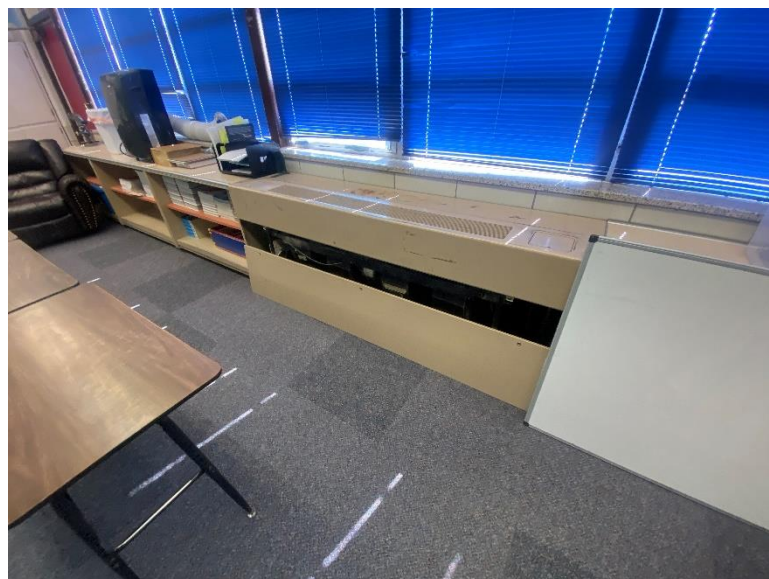
Description: PTACs located in the classrooms on the east (newest) side of the building are original to the addition and are beyond their design lives.

Classroom Unit Ventilator

Recommendation: Demo and remove the PTACs in the classrooms on the east side of the building.

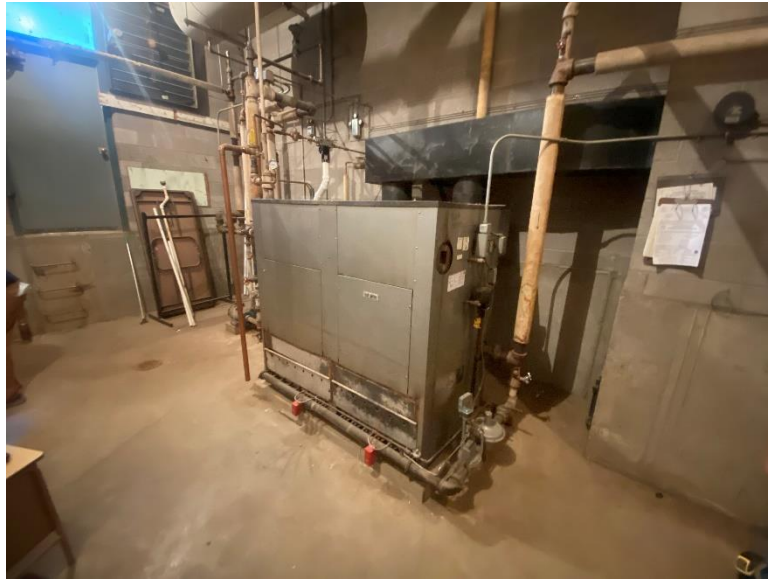
2.5.3 **Finding M4: Replace Boilers and Associated Pumps**

Description: The four (4) gas-fired boilers and associated boiler pumps are original to the building and are beyond their design lives. Corrosion and damage were observed on several boiler pumps. This is an energy savings opportunity.

Existing Gas-Fired Furnace

Recommendation: Replace the four (4) gas-fired boilers with high-efficiency modular boilers sized for new use and capacity. Replace the existing boiler pumps with new pumps sized for new use and capacity.

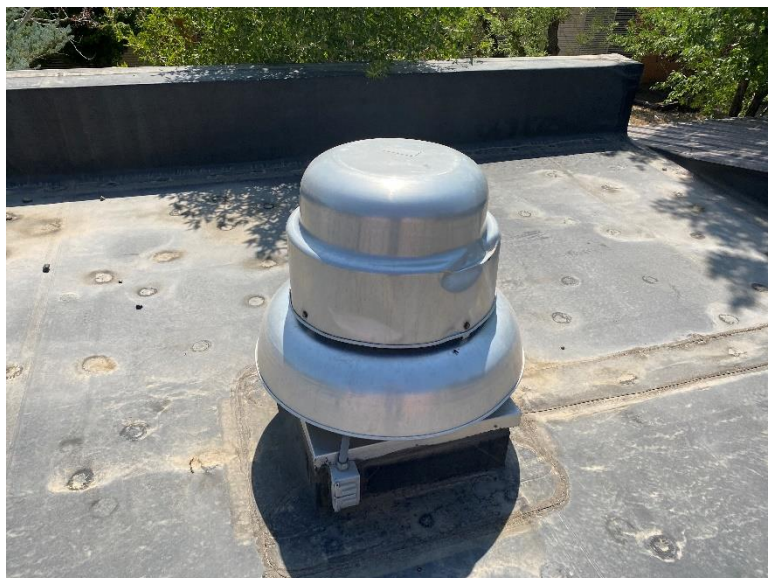
2.5.4 **Finding M5: Replace Bathroom Exhaust Fans**

Description: The exhaust fans in all restrooms are original to the building and are beyond their useful lives. The exhaust fans were observed to be excessively loud and rattling. This is typically a sign that the fan has reached its design life as the bearings fail or the fins fall out of alignment.

Bathroom Exhaust Fan on Roof

Recommendation: Furnish and install new exhaust fans for all restrooms.

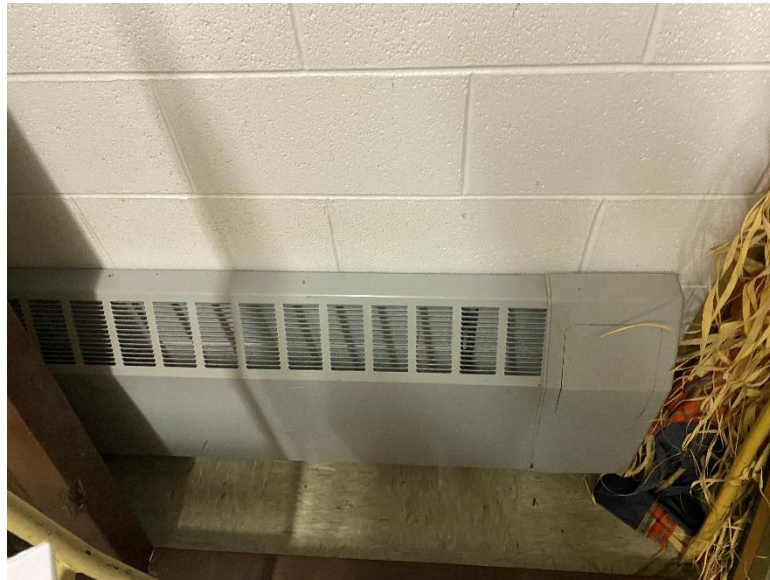
2.5.5 **Finding M6: Replace Baseboard Heaters**

Description: The baseboard heaters are original to the building and are beyond their useful lives. Several baseboard heaters throughout the building were observed to be damaged.

Baseboard Heater

Recommendation: Remove and replace the baseboard unit heaters throughout the building with units of similar capacities.

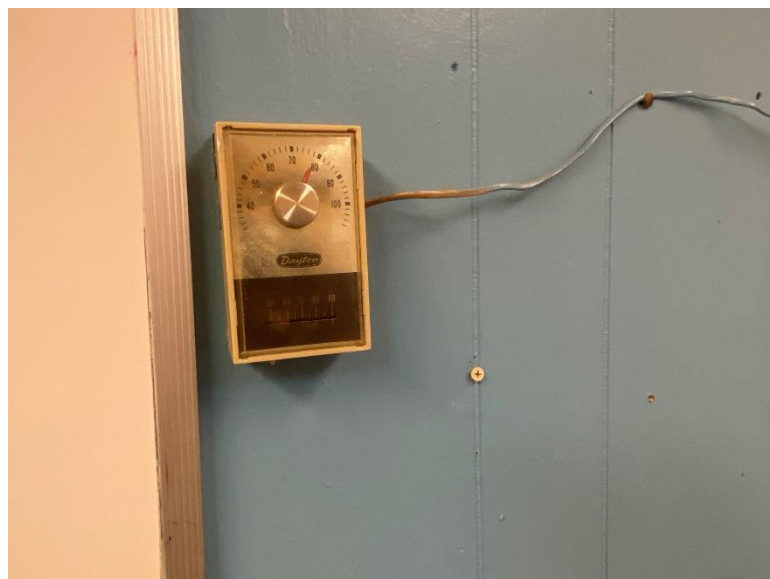
2.5.6 **Finding M7: Replace HVAC Controls**

Description: The thermostats throughout the building are original to the building and are beyond their useful lives. The thermostats require frequent maintenance and can be considered obsolete.

Existing Thermostat

Recommendation: Replace all thermostats with individual programmable thermostats.

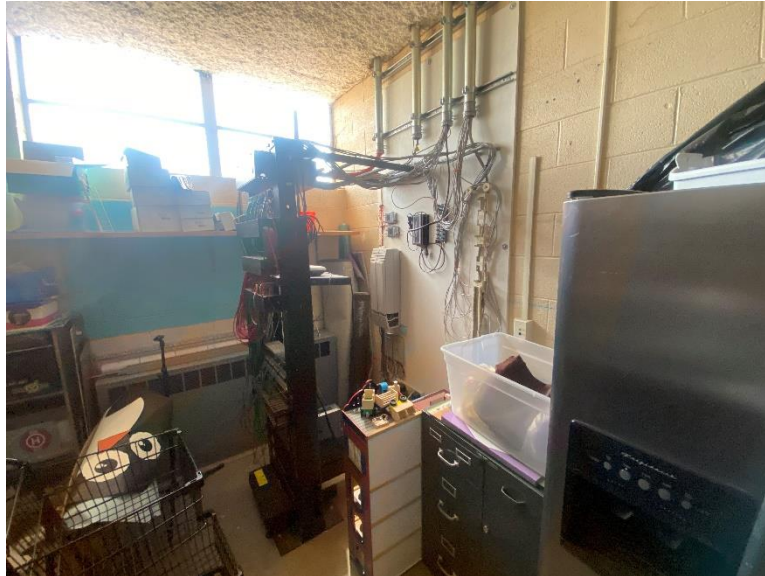
Description: There is no cooling system for the IT/Computer room in the library. The room gets excessively hot, which can cause the IT equipment to not function as intended.

Existing IT/Computer Room

Recommendation: Furnish and install a mini-split air conditioner for the IT/Computer room in the library.

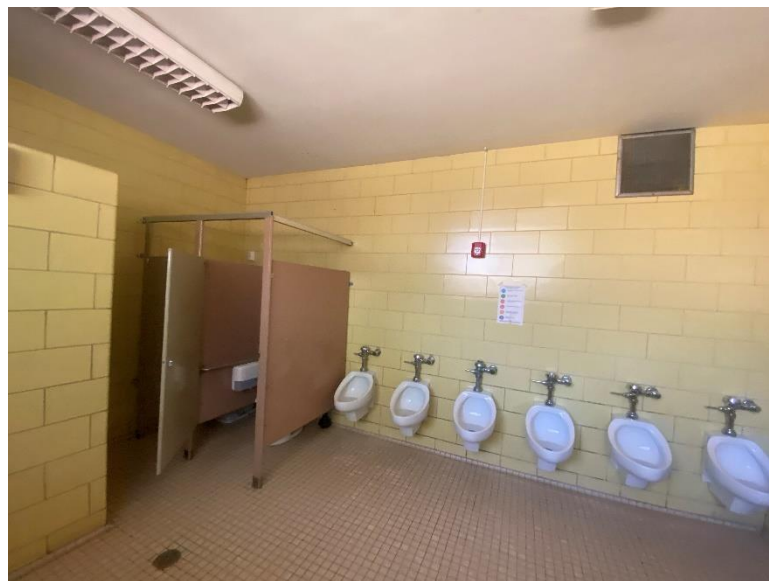
2.5.8 Finding M9: Replace Plumbing Fixtures

Description: Plumbing fixtures are original to the building and beyond their design lives. Plumbing fixtures are non-ADA compliant throughout the facility.

Existing Plumbing Fixtures

Recommendation: Replace all plumbing fixtures throughout building with ADA compliant, low-flow fixtures.

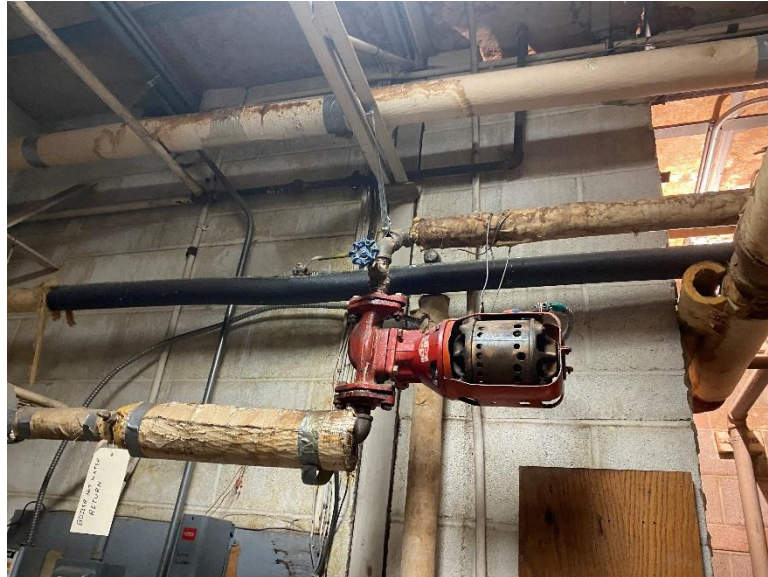
2.5.9 Finding M10: Replace Piping Systems

Description: hot water, cold water, and sanitary waste plumbing systems are original to the building are approaching the end of their useful lives. Extensive damage and corrosion was observed on piping in all mechanical boiler rooms. Hot water piping insulation was observed to be damaged or missing in several locations.

Damaged Hot Water Pipe Insulation

Recommendation: Replace hot water, cold water, and sanitary systems throughout the building as well as all associated pumps and appurtenances.

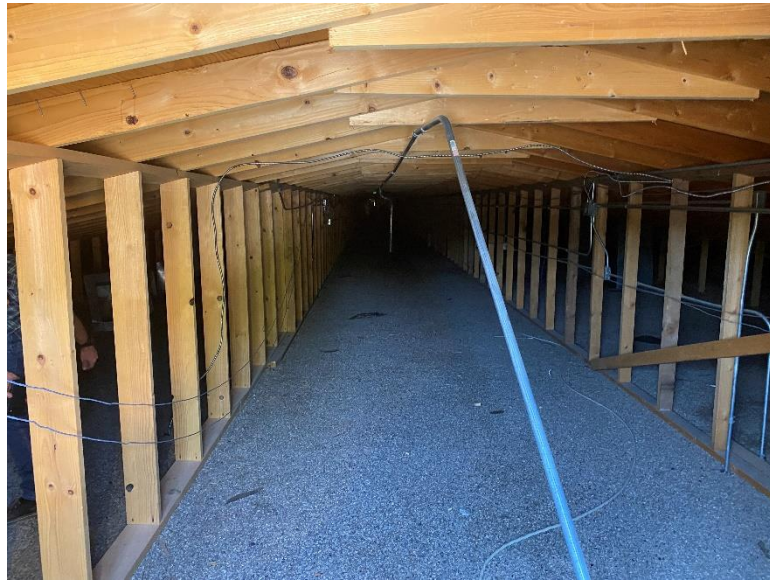
Description: There is no fire protection system installed in the main building. An NFPA 13 automatic sprinkler system is required for the current and future occupancy of the facility.

Typical Missing Fire Sprinklers in Attic Space

Recommendation: Furnish and install a fire sprinkler system throughout the main building as required by NFPA 13 code.

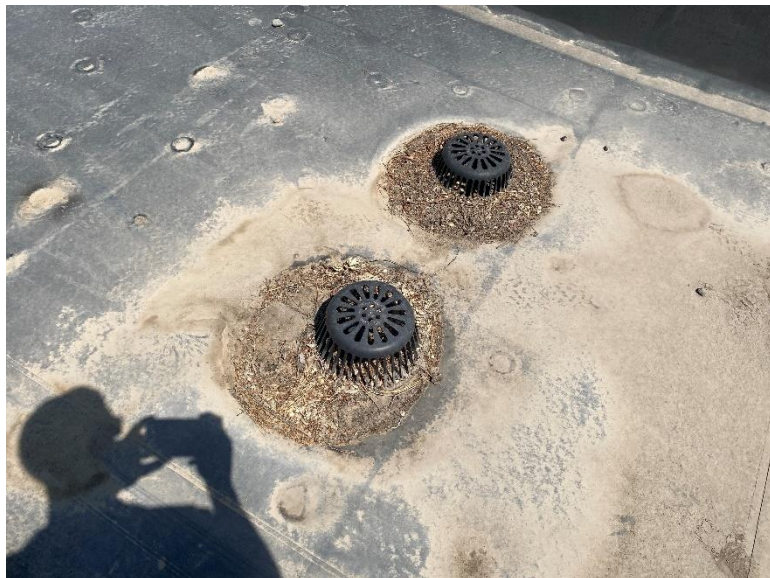
Description: The roof drains were observed to be clogged with leaves and other debris. Ponding and damage to the roof can occur if water is unable to adequately drain through the roof drains.

Clogged Roof Drain

Recommendation: Clean and clear the roof drains of leaves and debris. Develop maintenance schedule for routine cleaning of roof drains and downspouts to prevent future blockages.
